## Proactive Rehab

### Heads Off Potential Crisis

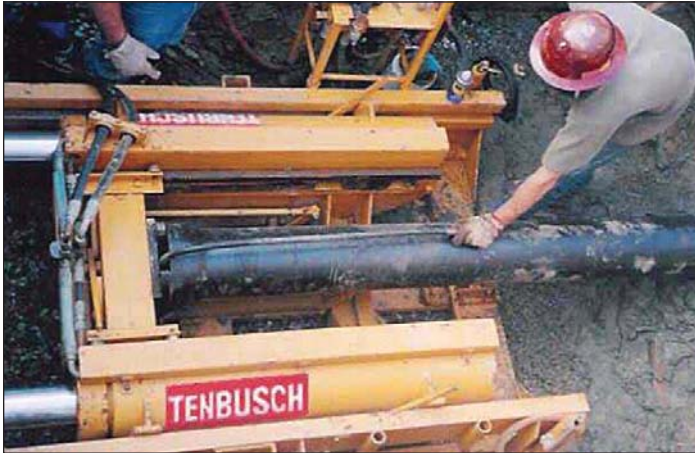
This is the set-up of the Tenbusch Jacking Unit during the Grant Road project.

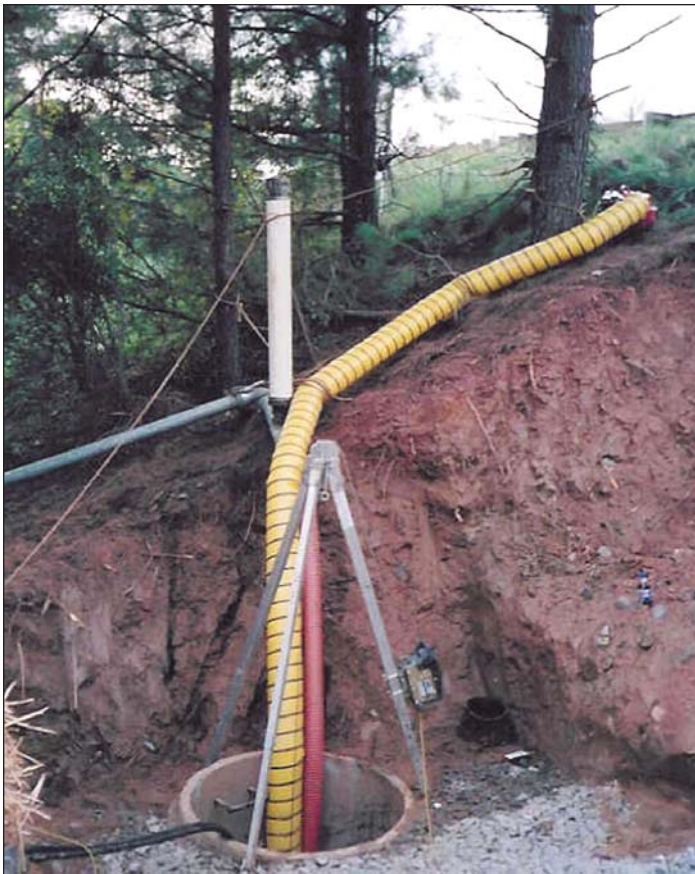
Pictured here is Grant Road and the deep manhole at the north end of the line segment being replaced. By excavating and removing the cone and first section - the manhole depth of 40 feet was reduced to 34 feet.

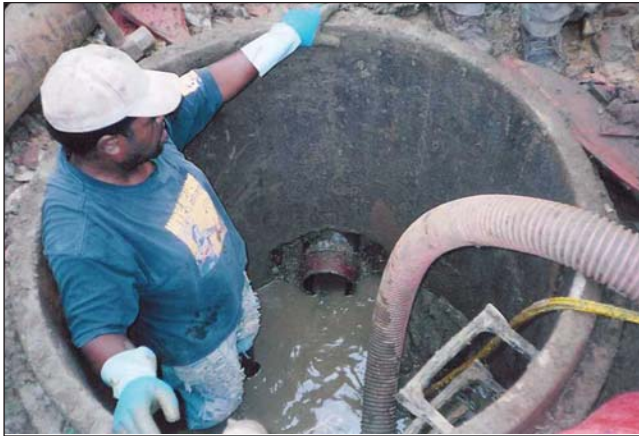
*Pictured here is the shallow end manhole that was used as the receiving pit. The new ductile iron pipe can be seen, as it has been pushed into the manhole four to six inches. The cone was removed to facilitate the work for the men.*

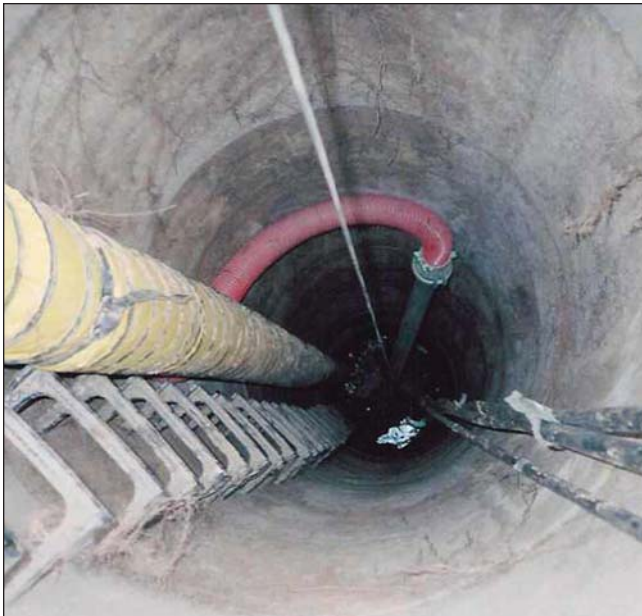
*The 34-foot deep manhole served as the receiving pit for the Tenbusch System "lead train." Replacing this manhole would have been especially expensive.*
