# Replacing existing 48" Corrugated Metal Pipe with new 54" Concrete Pipe in Delaware

Eastern States Construction, in Wilmington, DE was called upon to keep the traffic flowing while the failing line was replaced.

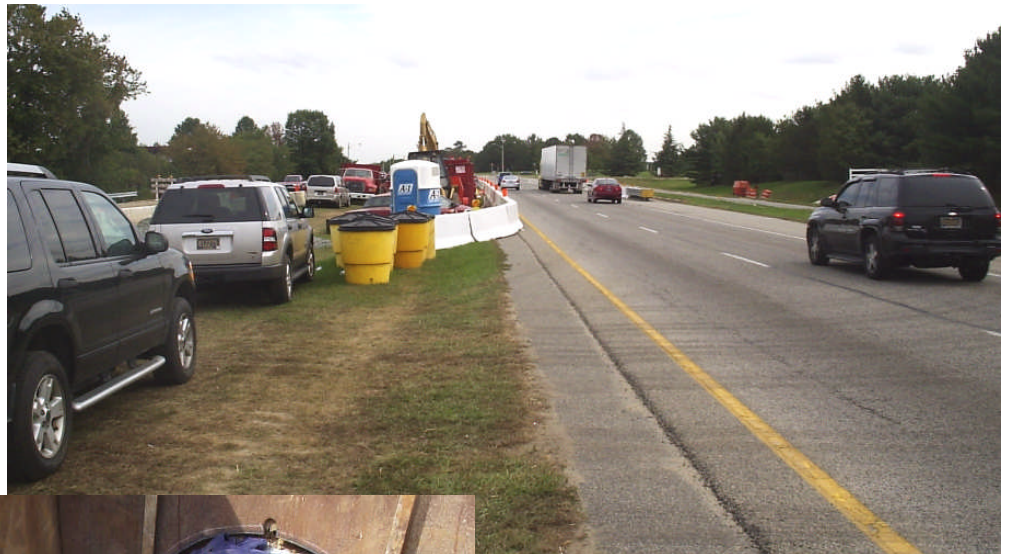
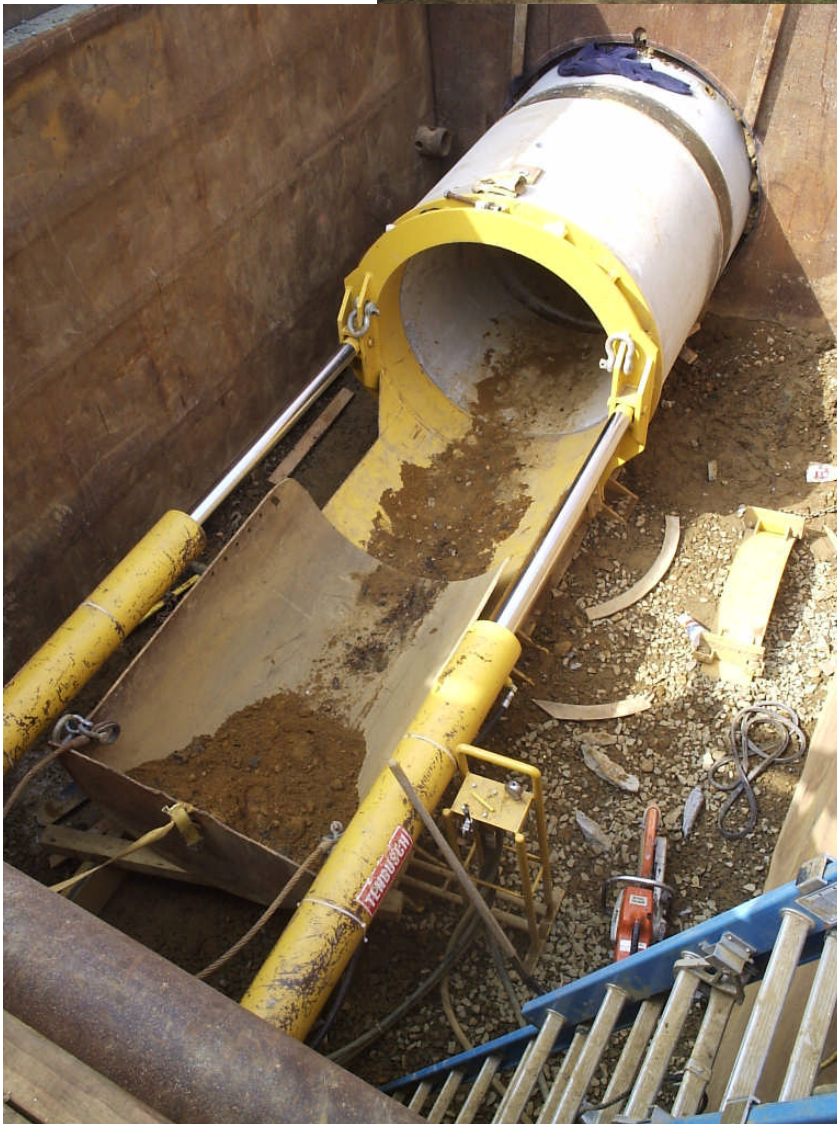
The shield shown above is attached to a joint of new RCP. Because the ground was stable, a simple shield was all that was required. It protected the men as they removed the old CMP and excavated a small amount of material to accommodate the new larger diameter pipe.

Tenbusch, Inc. supplies simple shields as shown above as well as more elaborate shields that can be steered (both mechanically and hydraulically) for use with concrete pipe, steel casing pipe, and tunnel liner plate. When using liner plate, the shield must be capable of advancing itself forward while protecting the men as they assemble more liner plate.

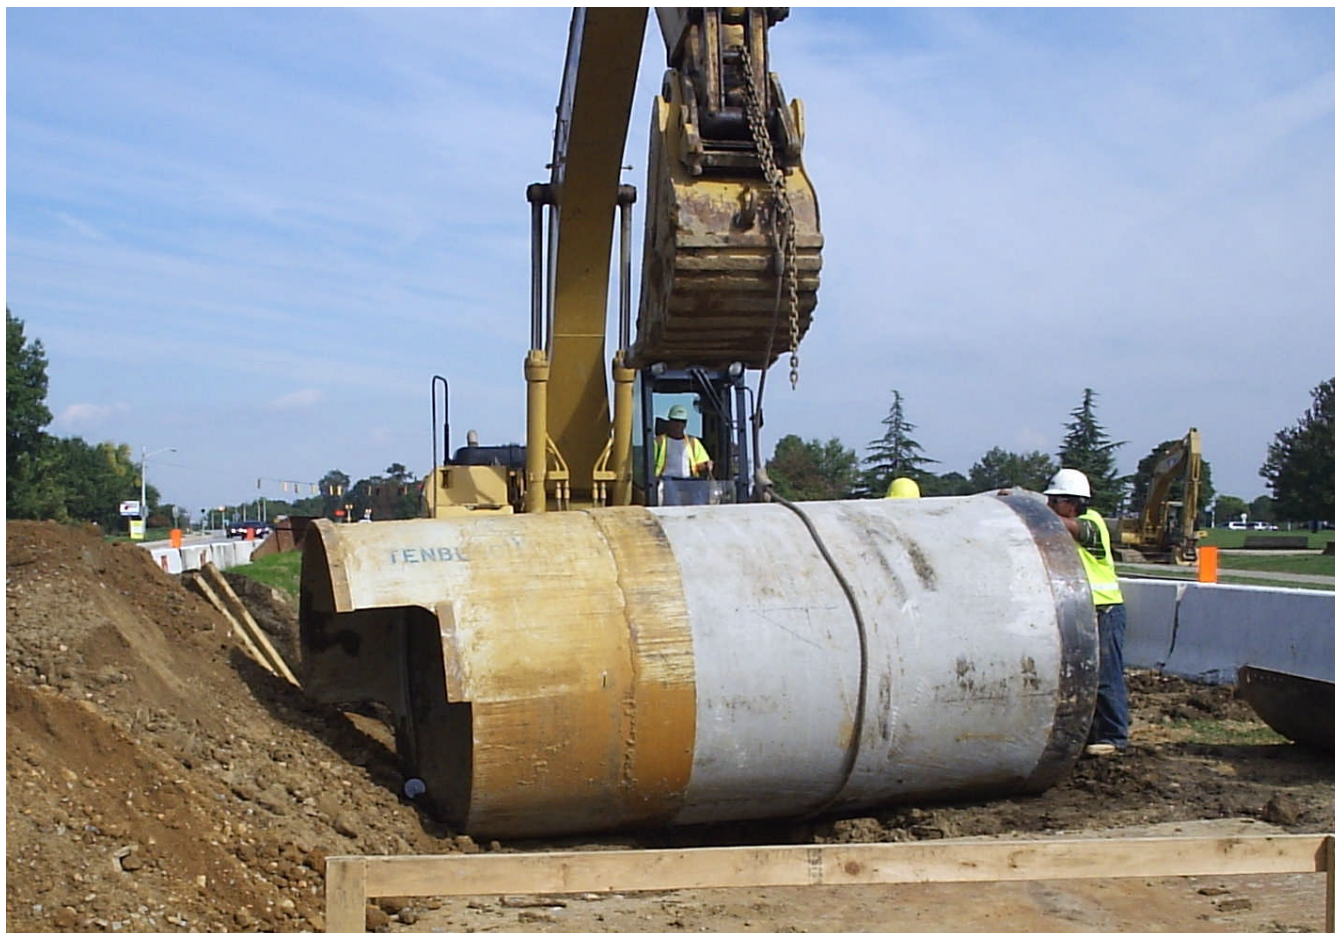
The photo above shows the small footprint that was required to do the work. The existing CMP was replaced in both directions from a work pit in the highway median.

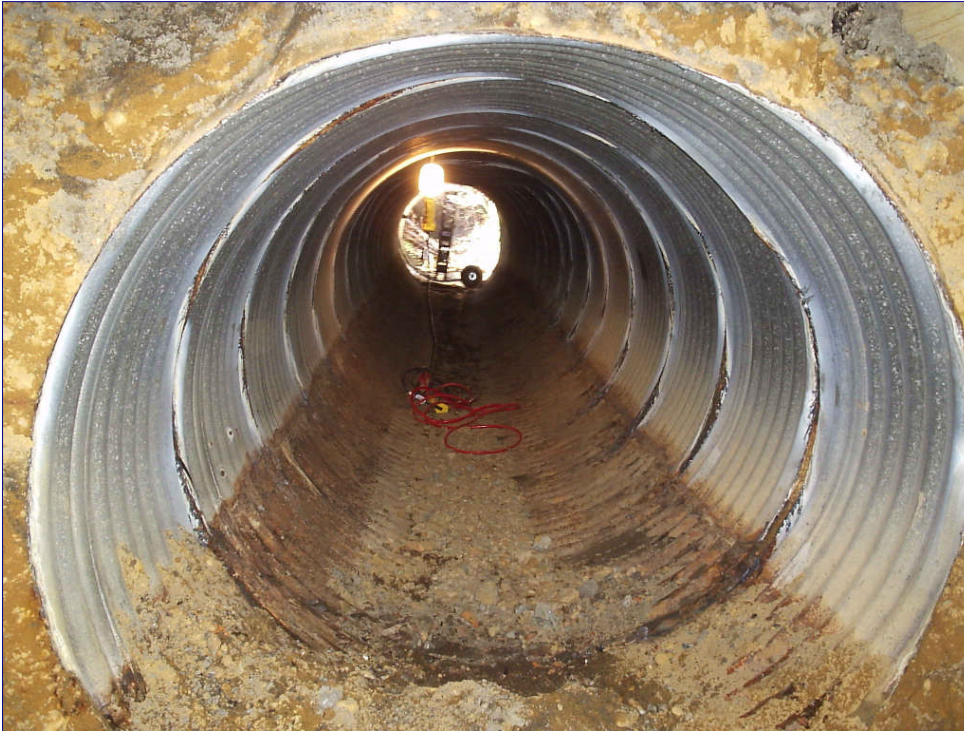
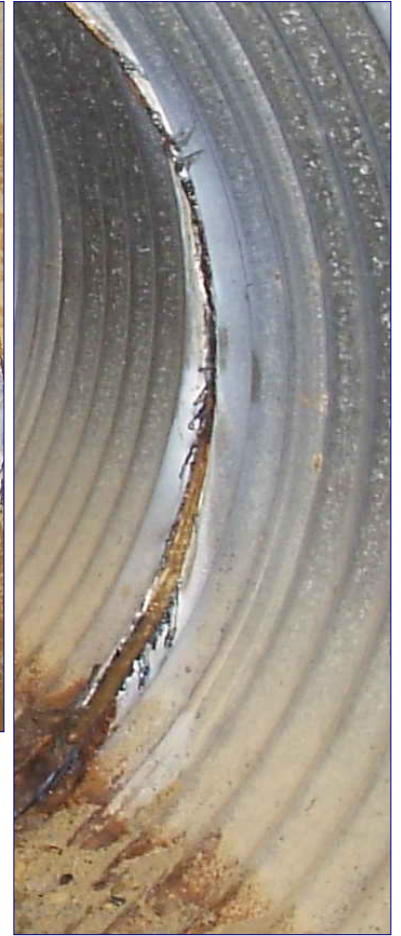
As you can see from the photo above and to the right – the seams of the existing CMP had deteriorated to allow bedding material to migrate into the pipe. This migration of bedding material has a dramatic effect on the structural integrity of this kind of pipe.

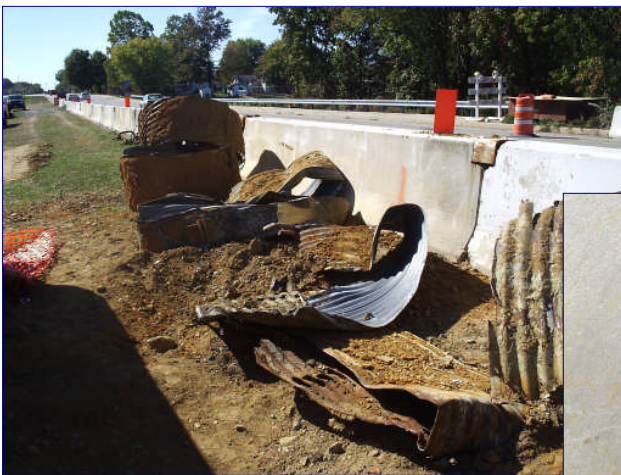
The old corrugated metal pipe was easily removed by the tunnel crew as they prepared the existing hole for the new Concrete Pipe.

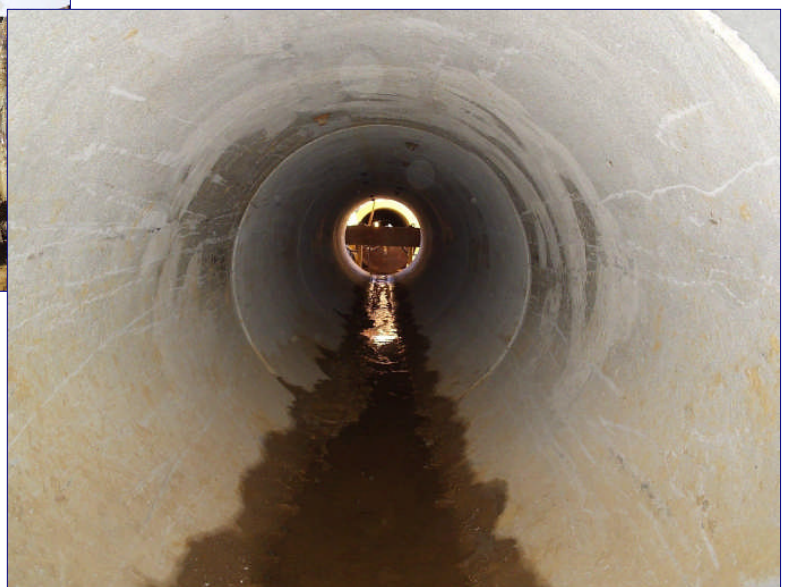
The photo to the right shows the new 54" Concrete Pipe installed
