***Failing Culverts –
The Geotechnical Perspective***

Al Tenbusch, President, Tenbusch, Inc.

August 2009

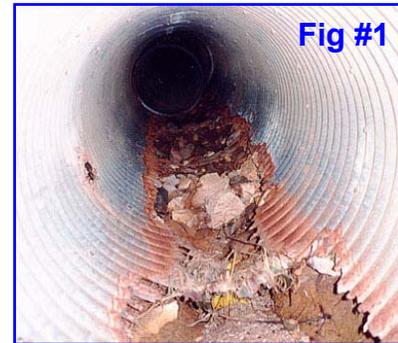
Corrosion was recognized early on as one of the major factors in determination of a CMP service life. Early corrosion protection was provided by galvanized or asphalt coatings applied to the metal and more recently by aluminum coatings. The coatings deteriorate at a slower rate than the pipe metal and thus extend the life of the metal pipe. Presently, most states design major highway culverts for a 50 to 75 year lifespan and require corrosion protection. However, a Missouri Department of Transportation study indicates that a coated corrugated metal pipe lifespan can be less than 20 years because of invert corrosion damage. Coating and pipe chemical corrosion occurs on the outside of the pipe from ground reaction and on both the inside and outside of the pipe by road salt contaminated surface water and chemically active groundwater. Physical damage to coating that leads to pipe corrosion occurs from bed load abrasion and by traffic or environmentally induced mechanical abrasion between soil and the culvert (see Fig #1 above).

A - Once the water flow has been allowed to erode the bedding under the pipe, the hydrostatic pressure that the bedding will see from time to time will begin to force water migration through the bedding. The bottom line is - it is too late. The bedding must be removed and the pipe replaced. Figure #1 above, is a good example of this problem.

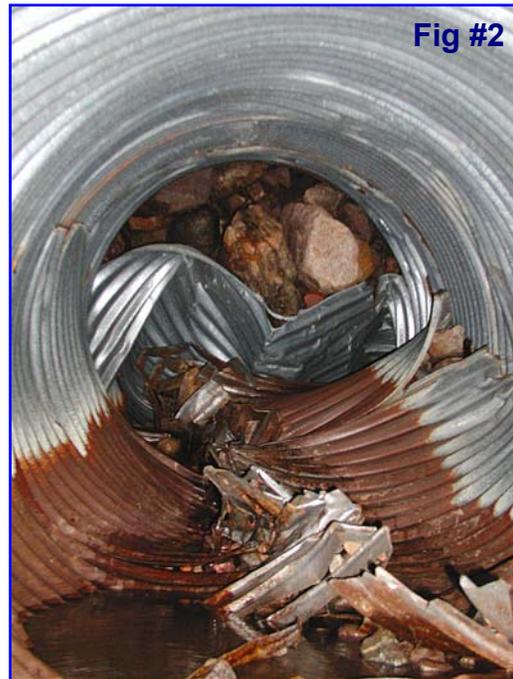
- 1) The invert deteriorates by corrosion or abrasion removing the hoop shape of the culvert, which is a source of the pipe strength. This break in the hoop allows the pipe to close in – effectively reducing the circumference of the pipe (Fig #2) thus removing the confinement for the structural fill allowing the fill to loosen and in some cases the bedding fill can become eroded again allowing the pipe to move in. As the pipe support is removed, the bottom of the pipe buckles upward, the sides of the pipe buckle in, and the top of the pipe will then buckle downward.

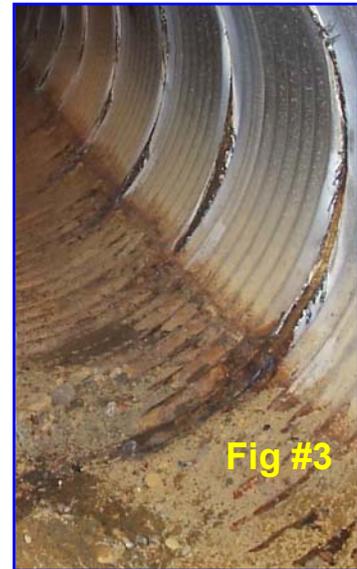
Fig #3

- 2) The pipe sidewalls and joints deteriorate and allow the bedding material to migrate through gaps in the pipe; this is aggravated by hydrostatic pressure reducing the structural fill strength. This allows the pipe to deflect outward at the springline, which effectively removes the arch structure supporting the top. (Fig #3).

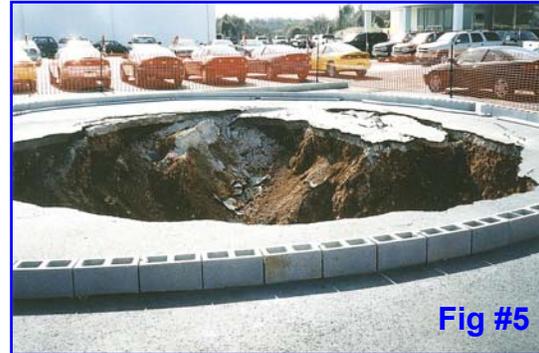
can continue to the surface and cause a sinkhole collapse. Once soil mass has been lost into the culvert and if the soil mass has not been remediated to the design density, the void will fill with looser soil that ravel from the top of the void. As the raveled soil gets deeper it compacts under its own weight thus resulting is a void at the top of the loose soil. This void will progressively work upward until there is sufficient arching within the soil mass to support the overlying soil or until the void reached the ground surface and forms a sinkhole (Fig #5). *The progress of this process is not predictable and may take several years before the results are realized.* Additionally, the surface water running through the system or the wet/dry cycles of moisture change within a granular soil which continues the void migration upward will not compact the soil that filled the void around the original hole in the culvert resulting in a weakened zone around the pipe that can significantly reduce the local buckling resistance of the existing culvert or of a liner.

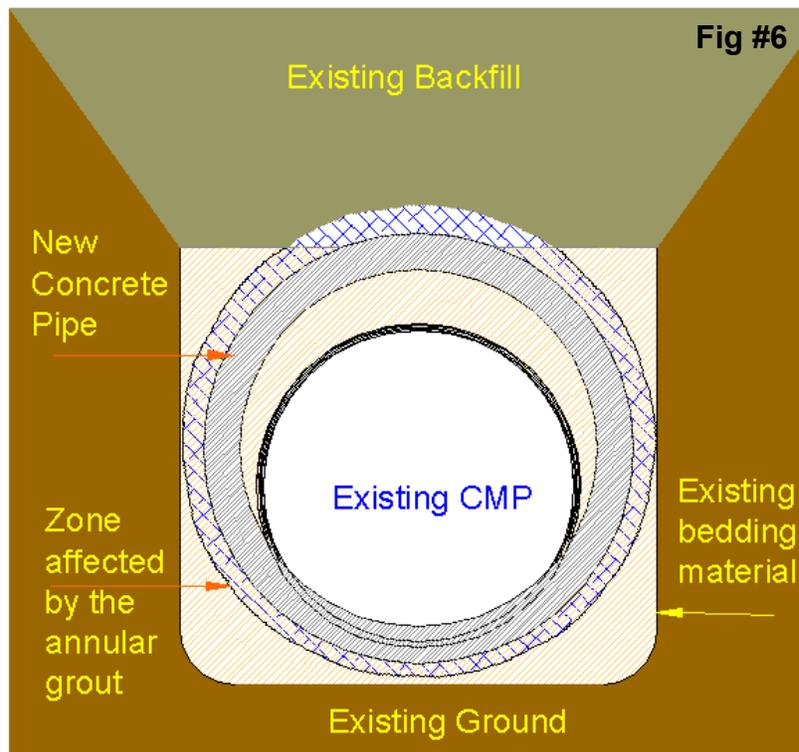
Tunneling cross section – new RCP through the existing CMP

The figure above illustrates how the existing bedding/granular fill has been removed during the tunneling operation.

- ✓ Chimney features in the soil above the original pipe. If the original pipe is replaced by open cut, the soil above the pipe will be replaced and compacted properly. If the existing pipe is replaced by tunneling, the base (the zone that is causing the chimney feature) will be replaced and annular grout will be installed. The settlement above can then be dealt with as it occurs at the surface knowing that it will not progress indefinitely.
- ✓ Granular bedding that has become uncompacted in the pipe zone. Most of the material will be removed in the tunneling process as shown in the diagram above.

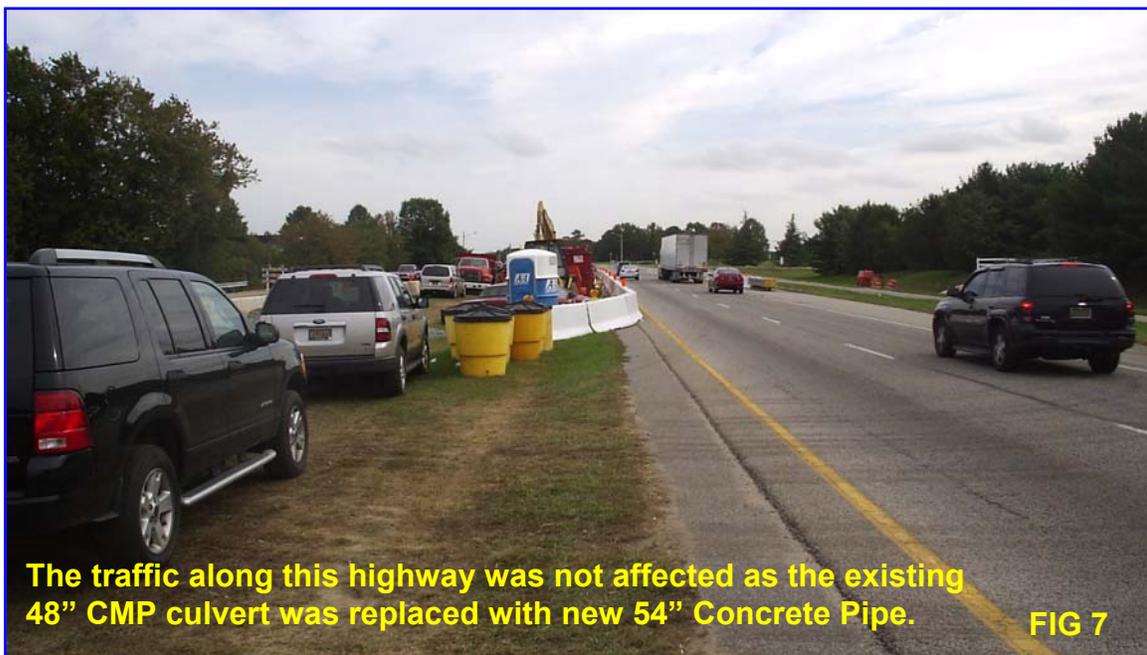
Many culverts, whether they are federal, state, or local, are located in high traffic areas or in deeper fills. Rehabilitation of these culverts has become a national problem, as there are few alternatives that do not impact traffic flow and local commerce (see Figure #7 above). Traditional tunneling methods have been found to be an economical and effective method of removal and replacement of these failing culverts as they can address both the damaged surrounding soil and the culvert material and significantly reduce the construction carbon footprint with the reduction in size and quantity of equipment. This alternative also allows the owner to upsize the existing capacity. Tunnelling allows for the replacement of the existing pipe without upsetting any other existing utilities. This geotechnical perspective has shown that there are several elements or mechanisms of pipe failure that work in concert to affect the total failure of the culvert. Tunneling creates a new structure with a new long design life material and a very long life expectancy.
